HISTORIC STRUCTURE REPORT

ST. PHILOMENA CATHOLIC CHURCH

KALAUPAPA NATIONAL HISTORICAL PARK
Molokai, Hawaii

January 1985

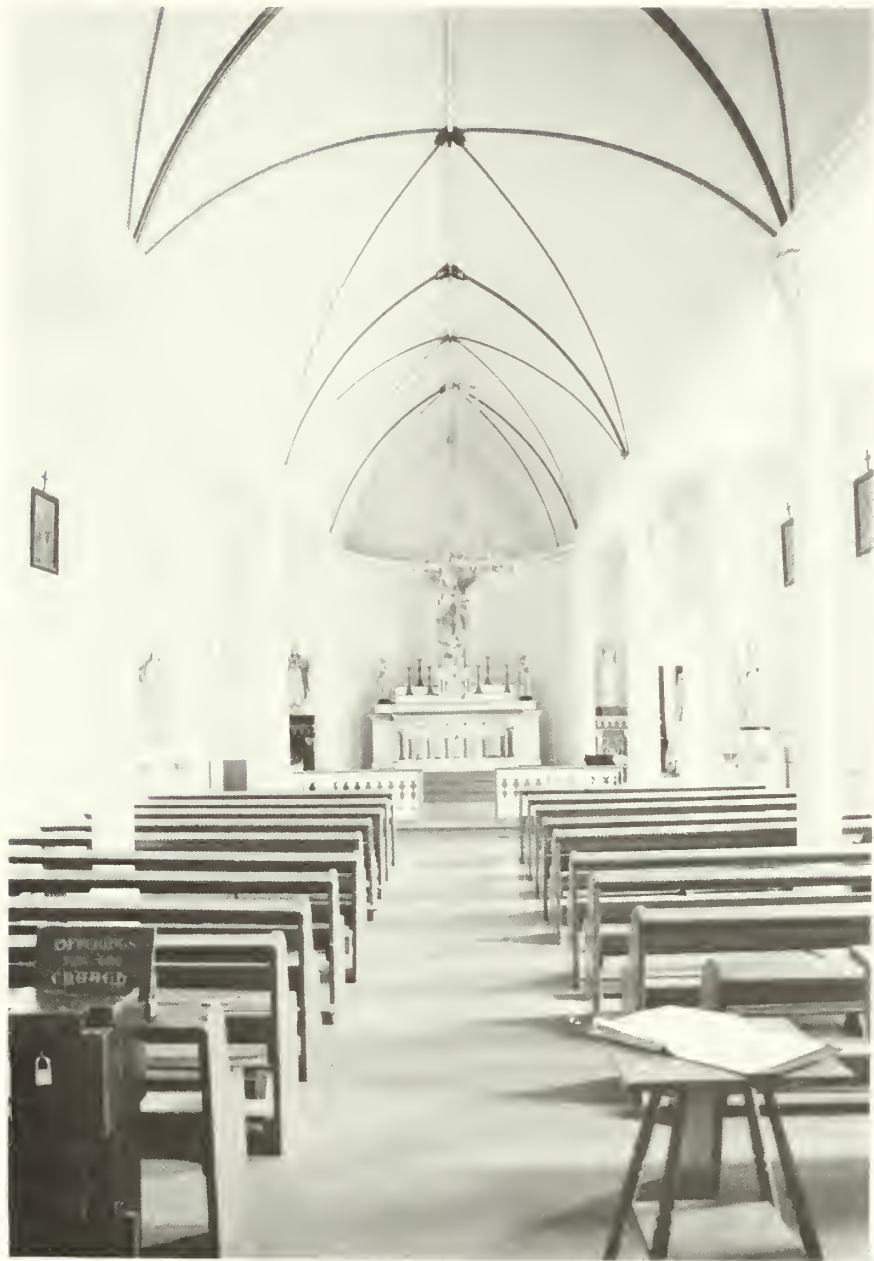
Illustration A6.

The 1888 nave as viewed from the crossing. The plastered masonry walls are painted white with the stone block pattern painted on in red. The flat 'side-aisle' ceilings and vault are of wood boarding and painted light blue. Columns and cornices are white. Water and dirt stains at the junction of the vault and wall are due to leakage at the roof to tower flashing. This leakage has damaged the stations of the cross on the south wall. 8/84. P.C.C.

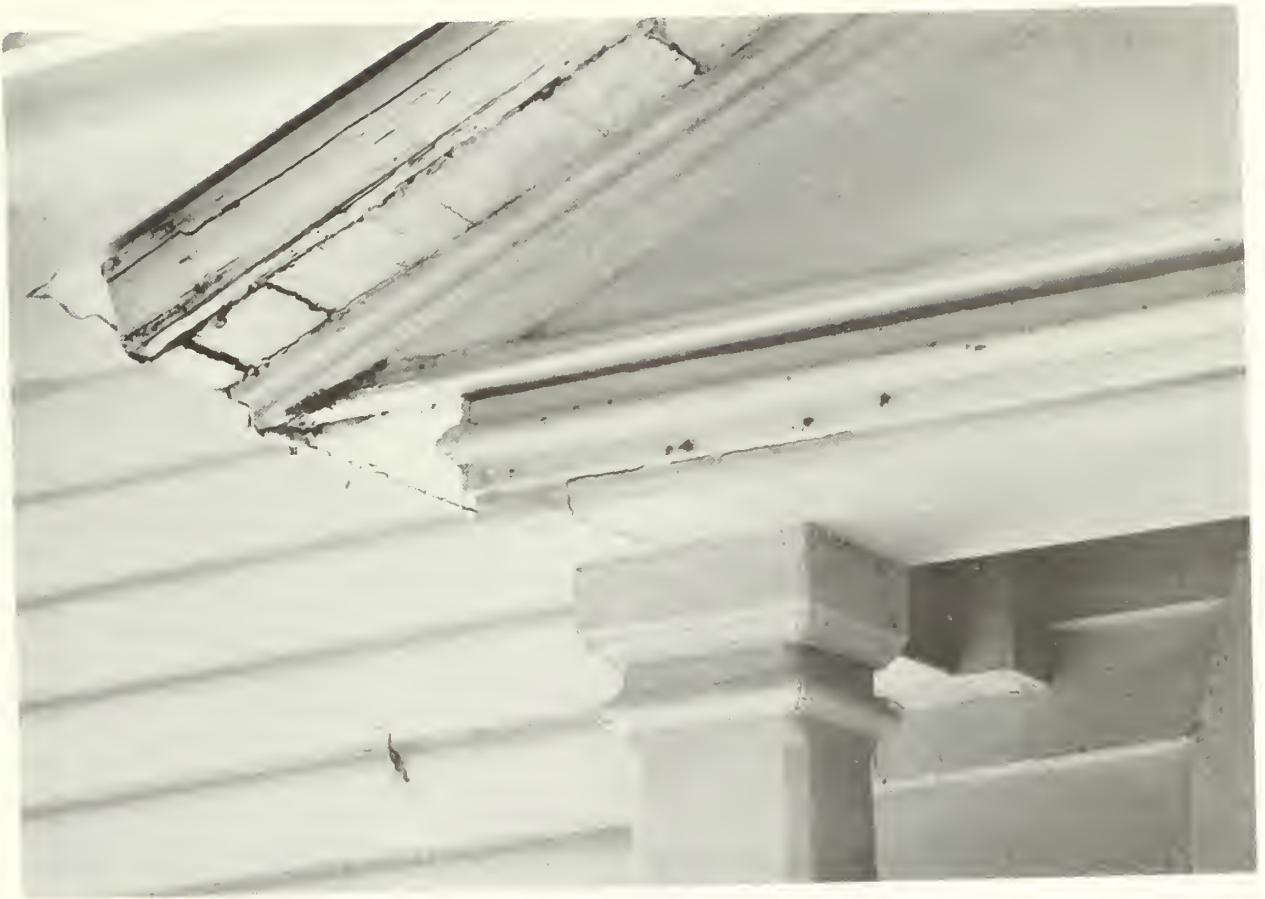
Detail at 'northwest' corner of 'west' portico roof, 1876 nave. Framing, sheathing, trims and moldings are extremely deteriorated due to air-borne termite damage and rot. Note the sand-textured paint. All of the wood sections of the building are finished in this manner. 6/84. R.L.C.

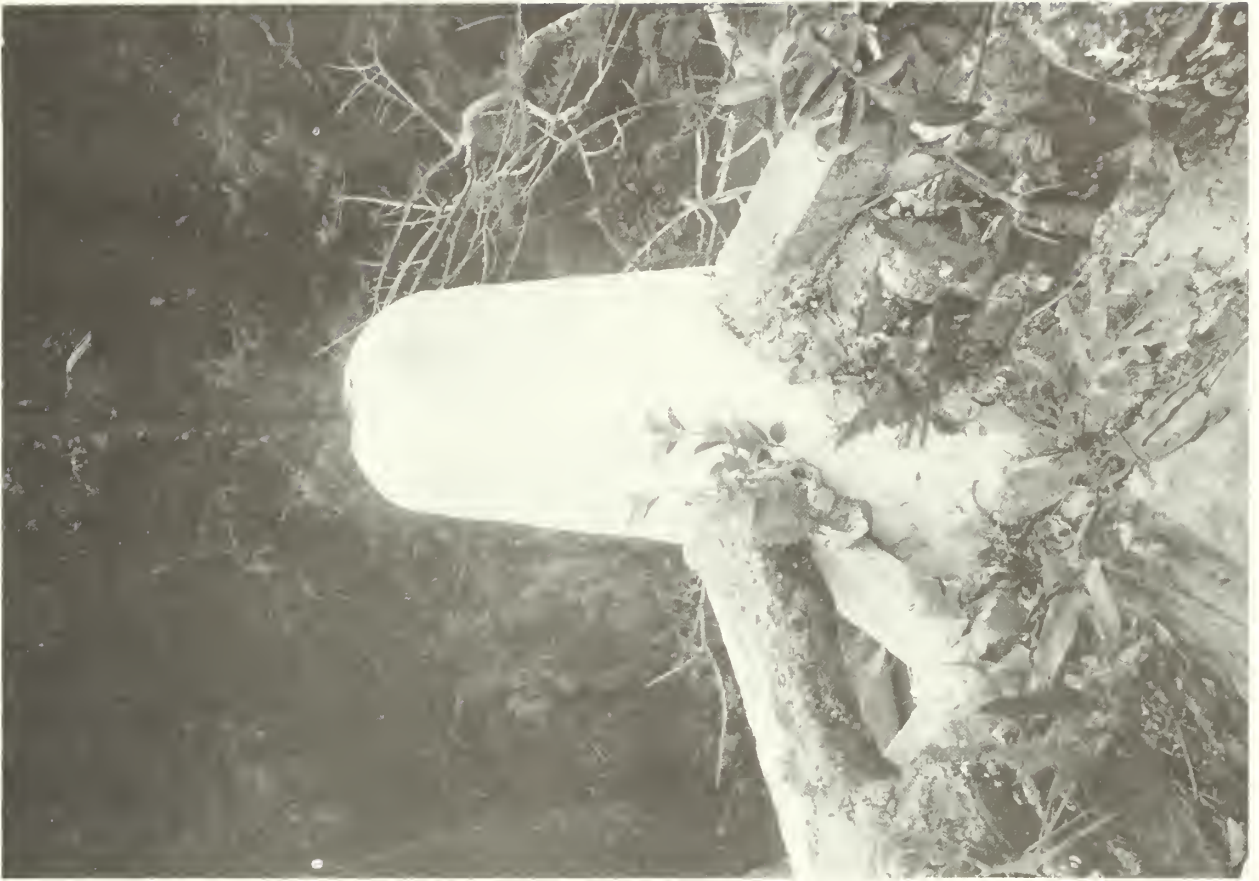
Illustration A26.

'Southwest' pinnacle showing vegetation growth in masonry which forces masonry work apart and allows water intrusion. 5/84. H.G.L.

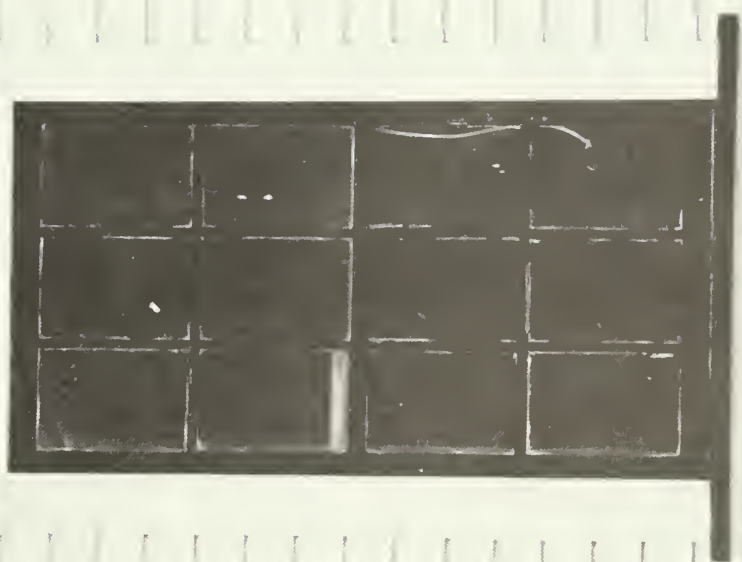
Illustration A37.

Detail of one of the inverted 'U'-shaped iron elements in the upper part of the 'east' wall masonry. If any exist in the 'west' wall, they are not visible. Their purpose has not been determined. 8/84. P.C.C.

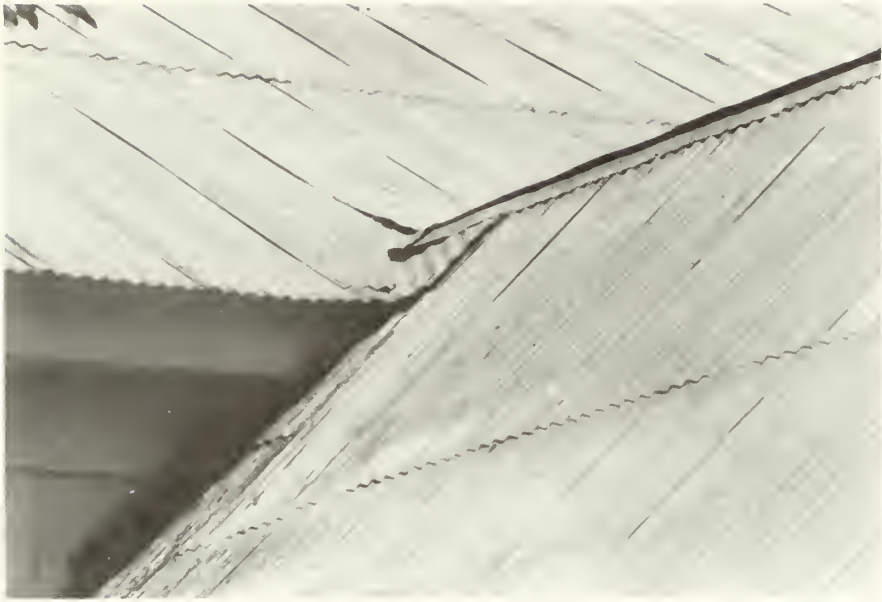
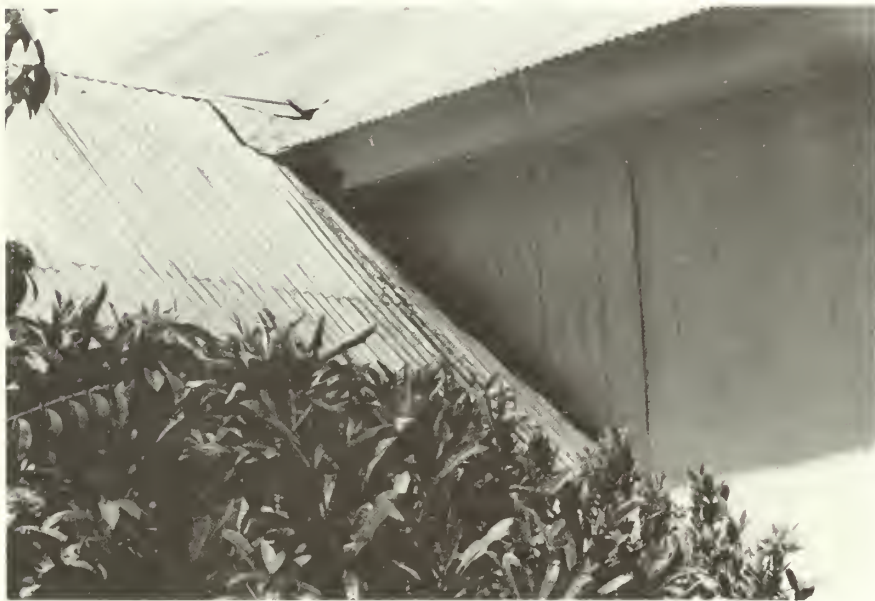
Illustrations A39 and A40.

Details of flashing at juncture of 1876 and 1889 roofs. Also note the vertical siding which is at both sides of the 1876 roof. 6/84. R.L.C.

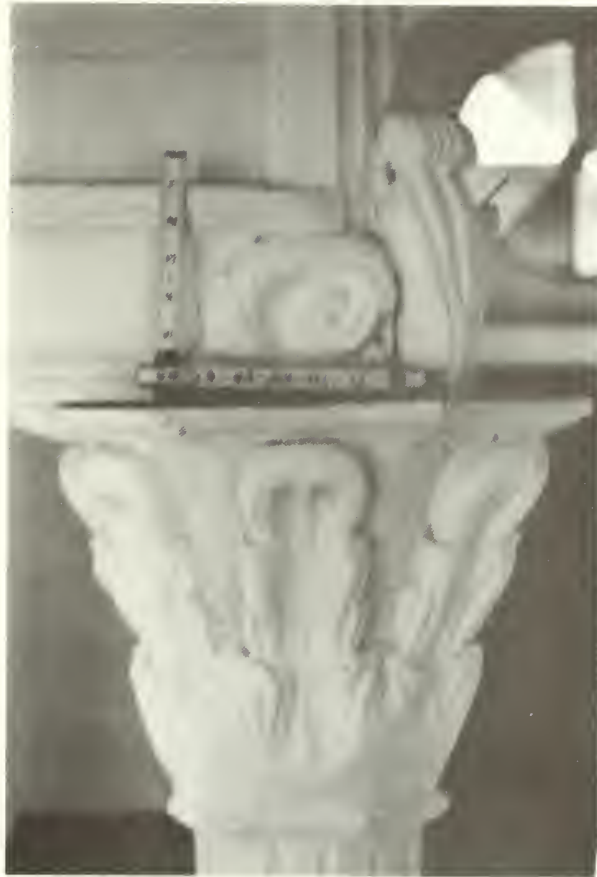
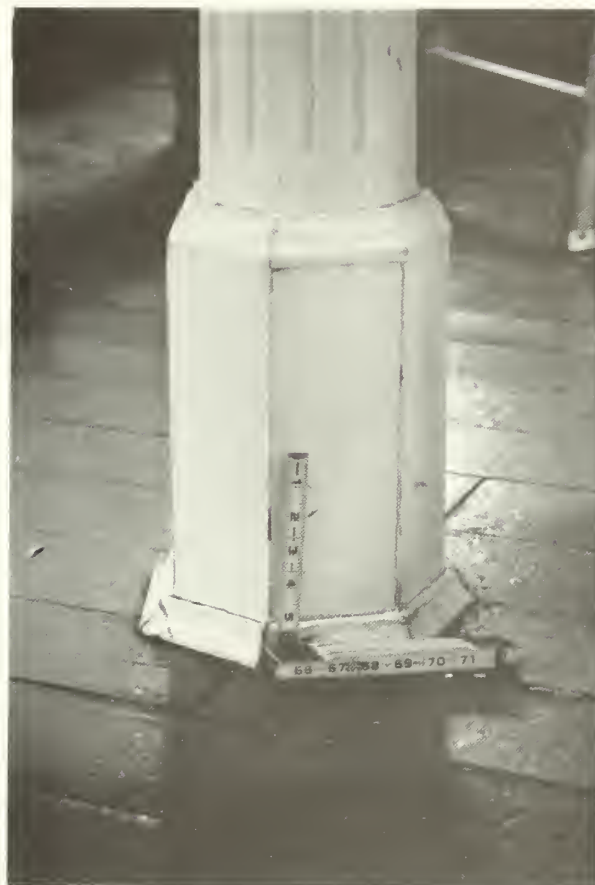
Illustrations A44 and A45.

Details of capital and base of column at intersection of 1876 nave with crossing. The two columns at this intersection are seven-sided, whereas the larger columns of the 1888 nave are octagonal. Some column capitols have been repaired with a fiberglass filler. 8/84. P.C.C.

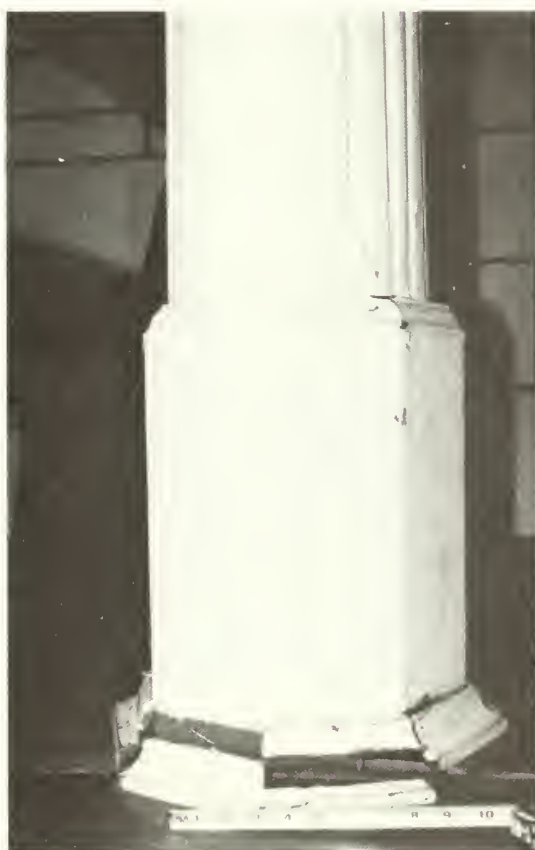
Illustrations A50 and A51.

Details showing subsidence of floor of 1888 nave. The greatest settlement occurred in the area of the two 'southern-most' columns. Repairs to the wall plaster have failed as the cement plaster mix did not bond to the earlier lime plaster. 8/84. P.C.C.

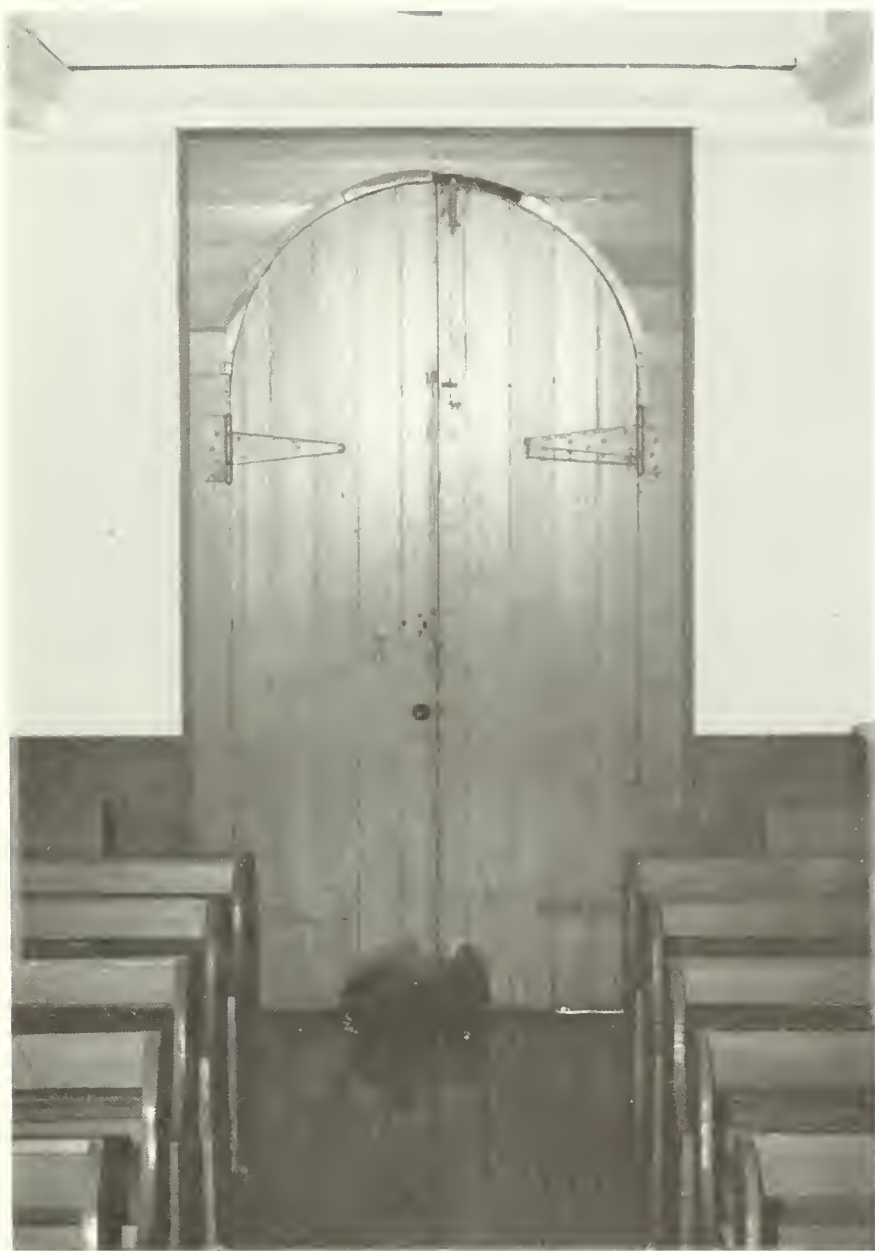
Illustration A57.

Hardware detail, interior of 'west' entry door, 1876 nave. Three periods of hardware are evident, the missing rim lock probably the intermediate set. Part of the wood slide-latch is obviously missing. 8/84. P.C.C.

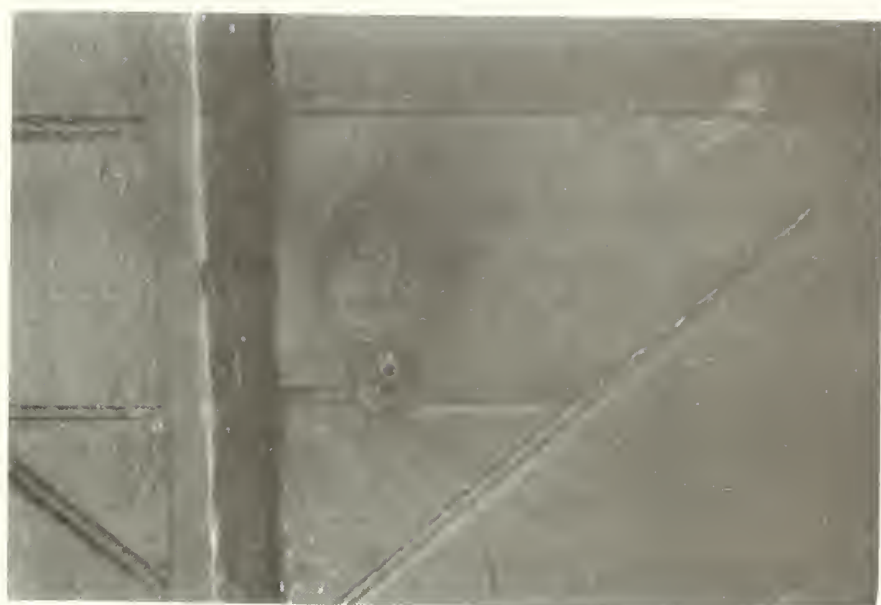
Illustration A58.

Hardware detail, exterior, 'west' entry door, 1876 nave. This lockset is inoperable. 8/84. P.C.C.

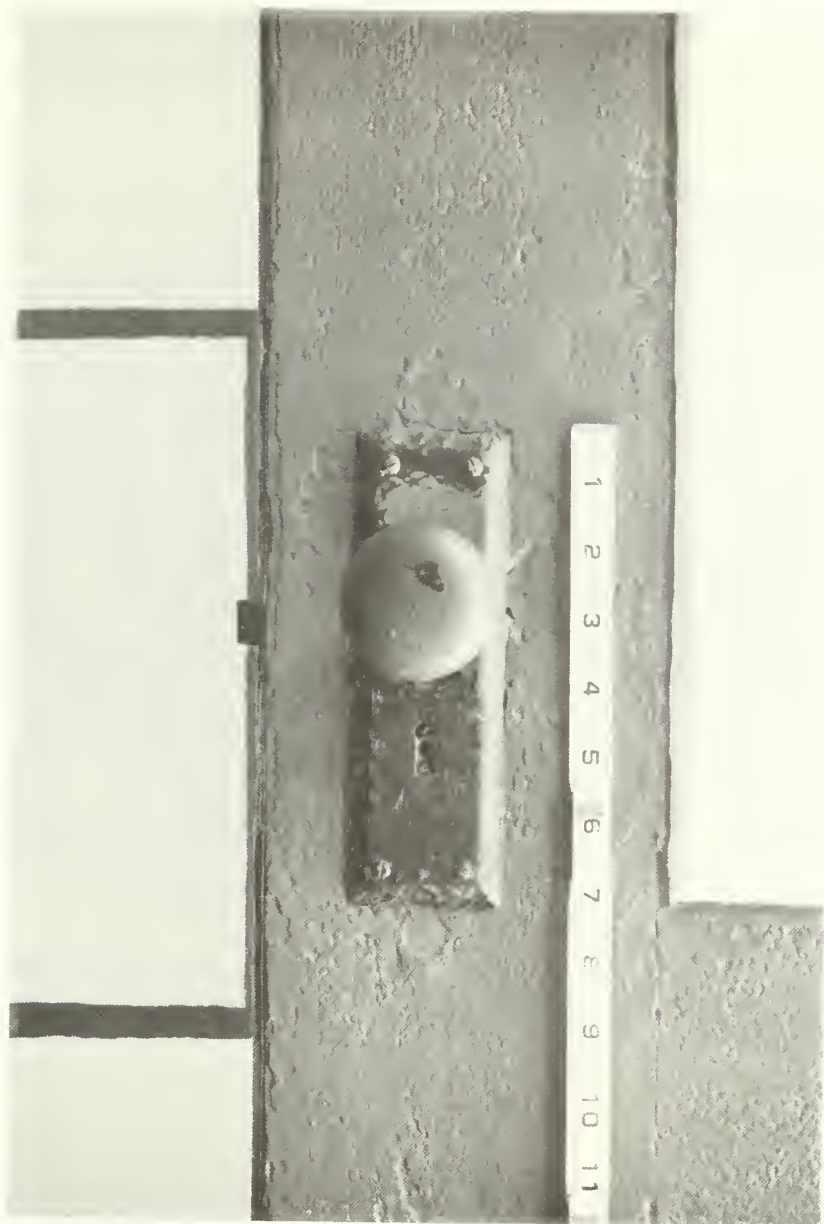
Illustration A59.

Hardware detail, 'south' entry, 1888 nave. This lockset is only partially operable. 8/84. P.C.C.

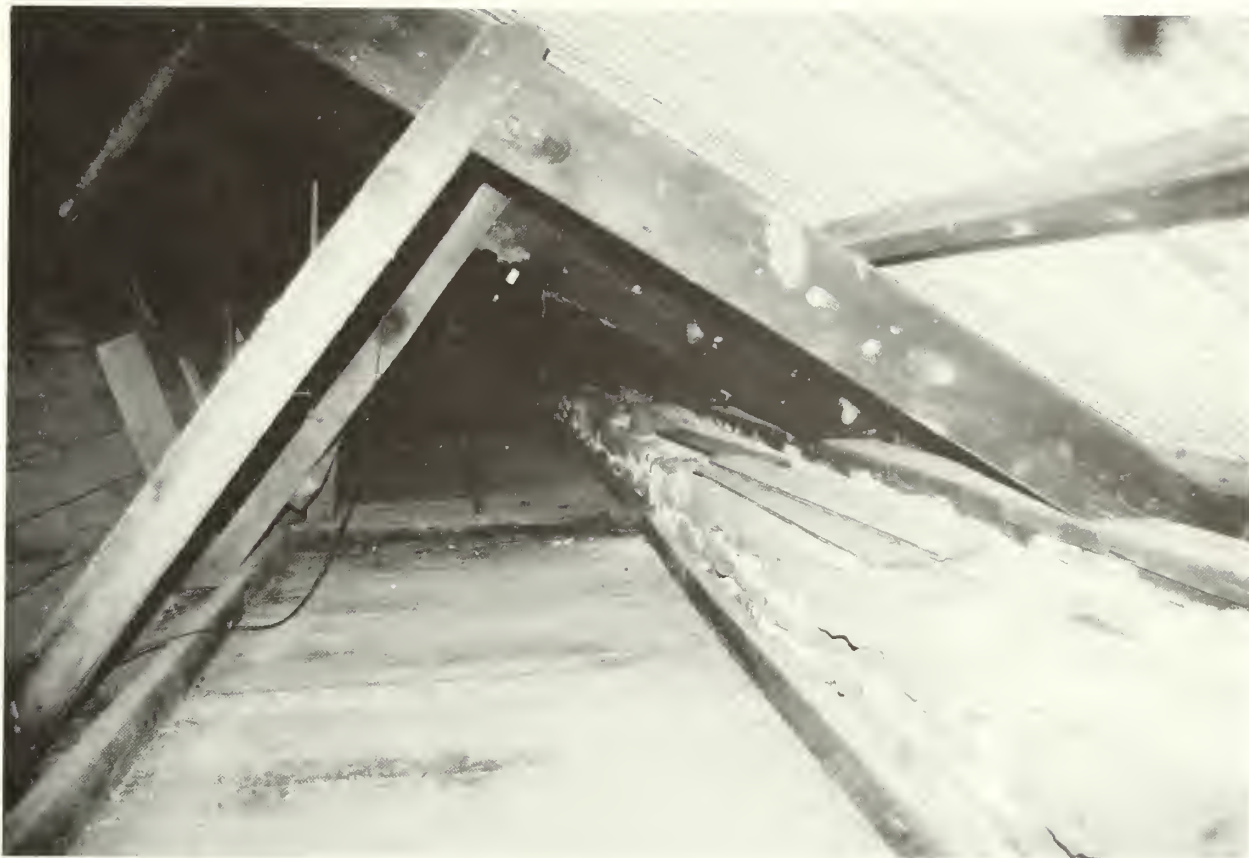
Illustration A61.

Attic along 'west' side of 1888 nave vault, view toward south. Part of the flat 'side-aisle' ceiling boarding has been replaced, probably ca. 1969. There are no visible anchors securing the double 2x8 rafter bearing plate to the stone wall. 8/84. P.C.C.

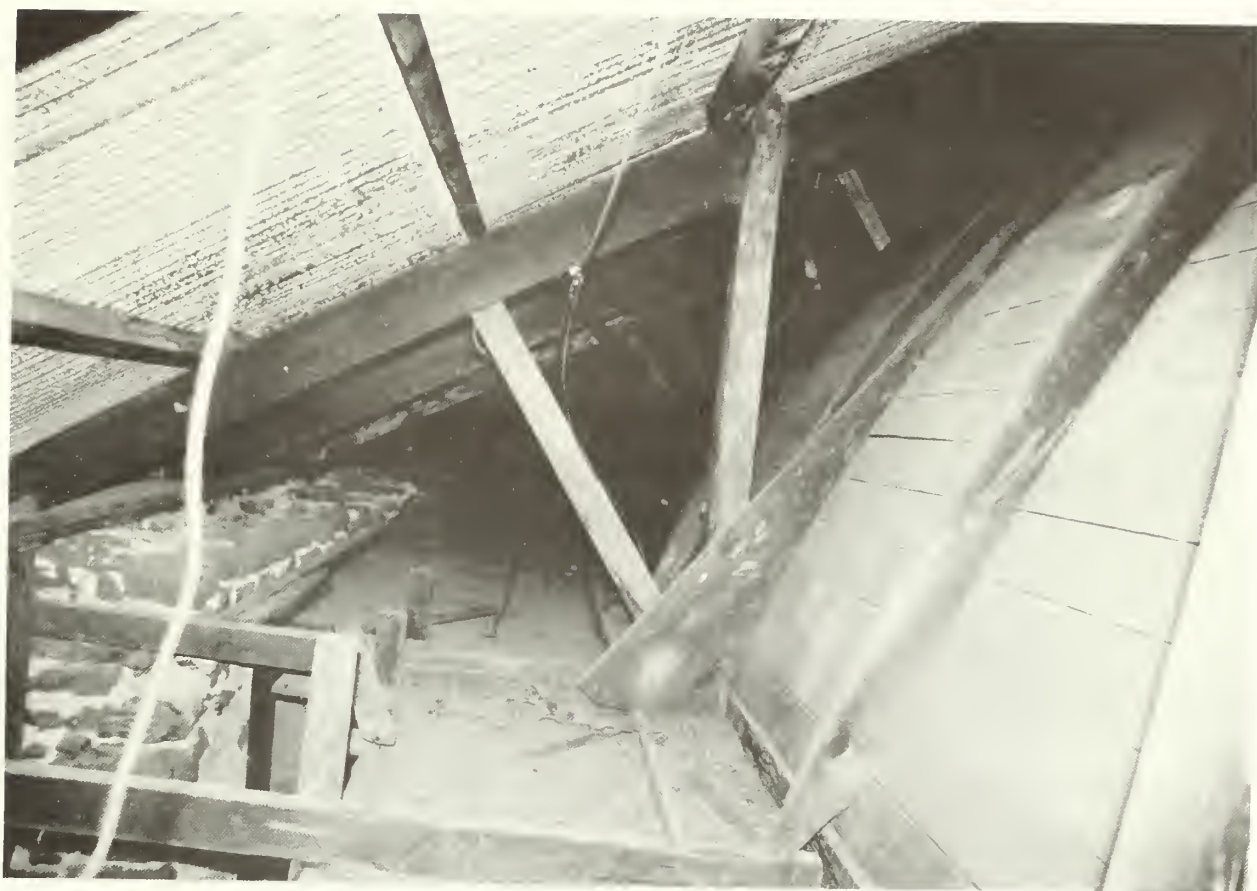
Illustration A63.

Attic along 'east' side of 1888 nave vault, view toward south. Most rafters and vault ribs are sound, but the vault base plates, a flat 2 inch by 10½ inch member on this side (lower center of photo), are extremely deteriorated from air-borne termite infestations. Most of the weight of the vault is probably carried in suspension from the rafters. The end of the stone wall is also visible in this photo. 8/84. P.C.C.

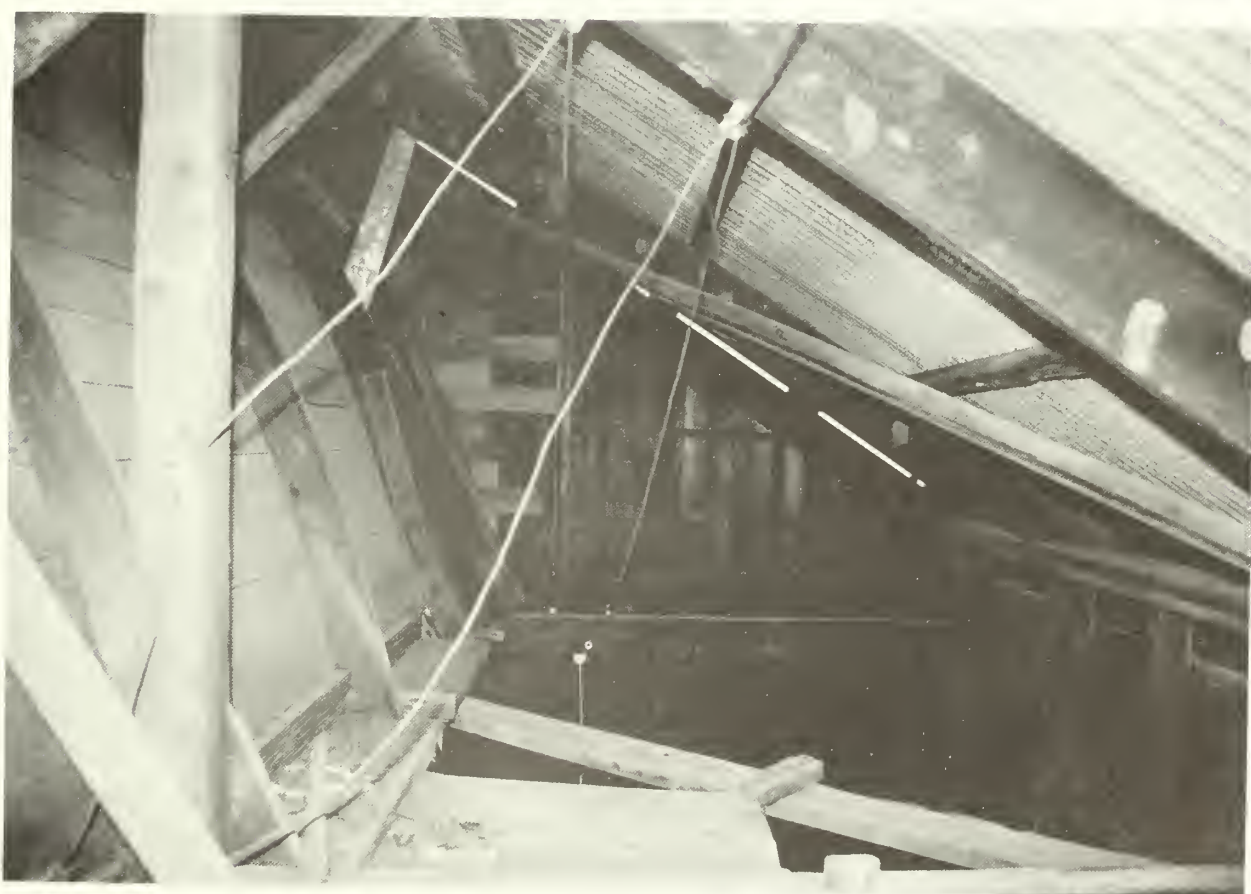
Illustration A64.

Attic along 'east' side of 1888 nave vault, view toward 'north', showing wood frame portion of building, open to the east sacristy below. The deteriorated vault base plate is at lower left. 8/84. P.C.C.

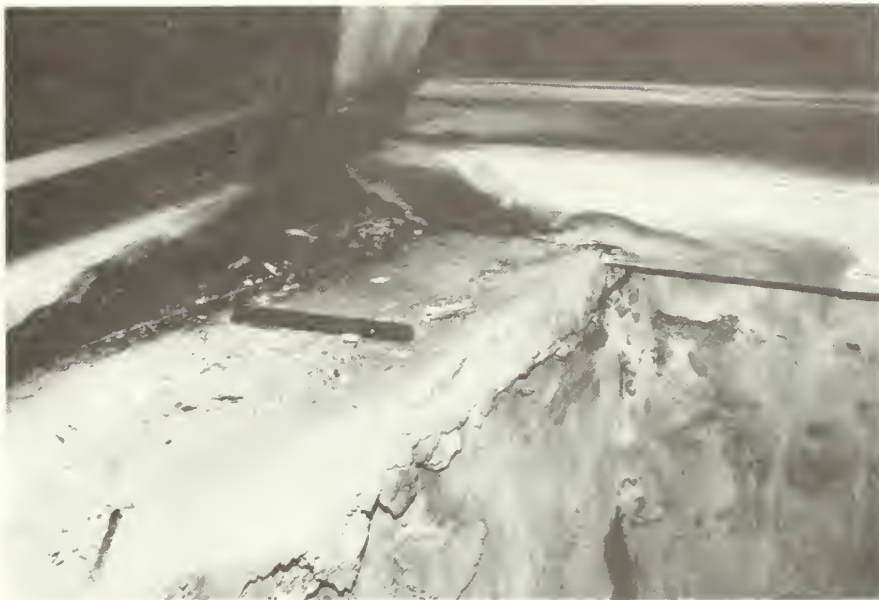
Illustration A66.

Detail of deteriorated base plate of bell tower roof at 'southeast' corner.
8/84. P.C.C.

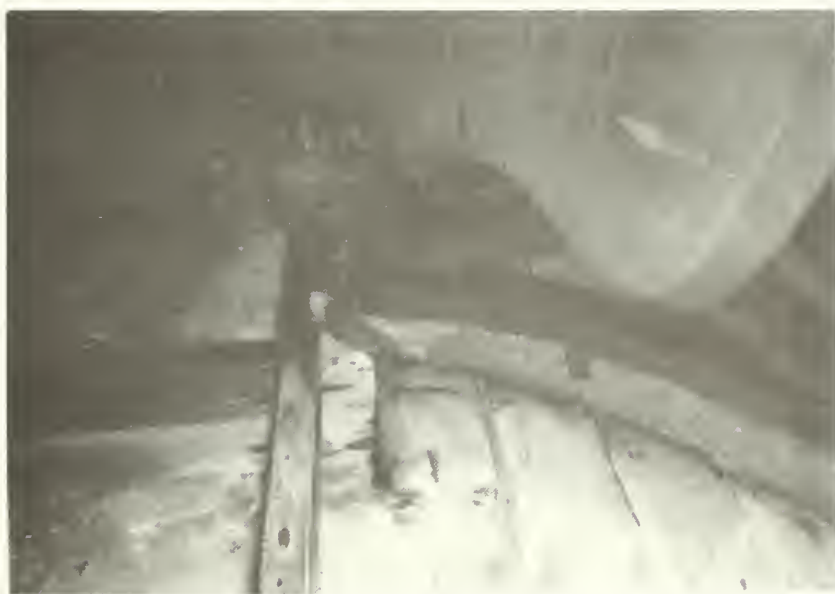
Illustrations A70 and A71.

Details of the deteriorated bell yoke. The bell is frozen because of the rust and exfoliation of the iron. 6/84. R.L.C.

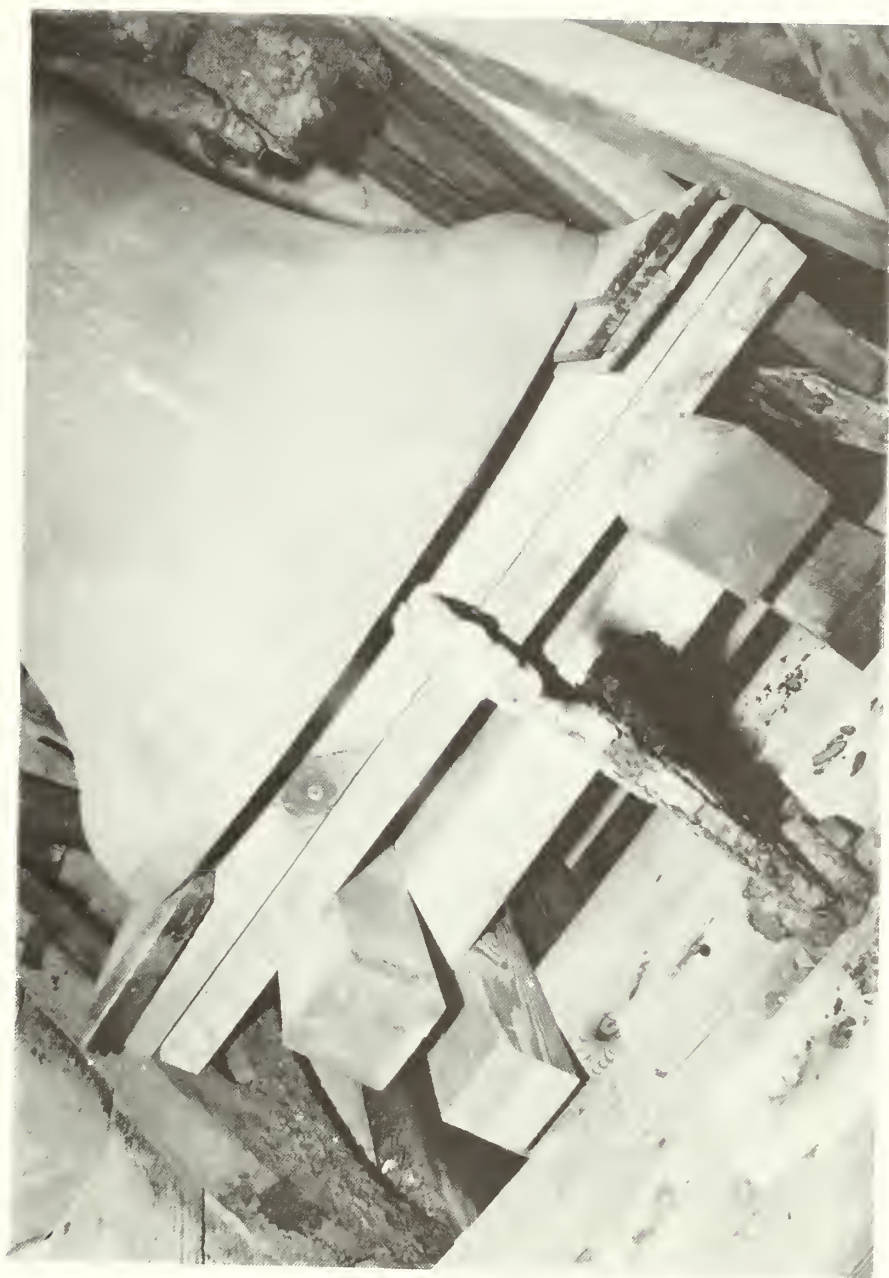
Illustration A72.

Detail showing cribbing installed in August, 1984 as a safeguard against failure of the deteriorated shafts and connections of the bell yoke. 8/84. P.C.C.

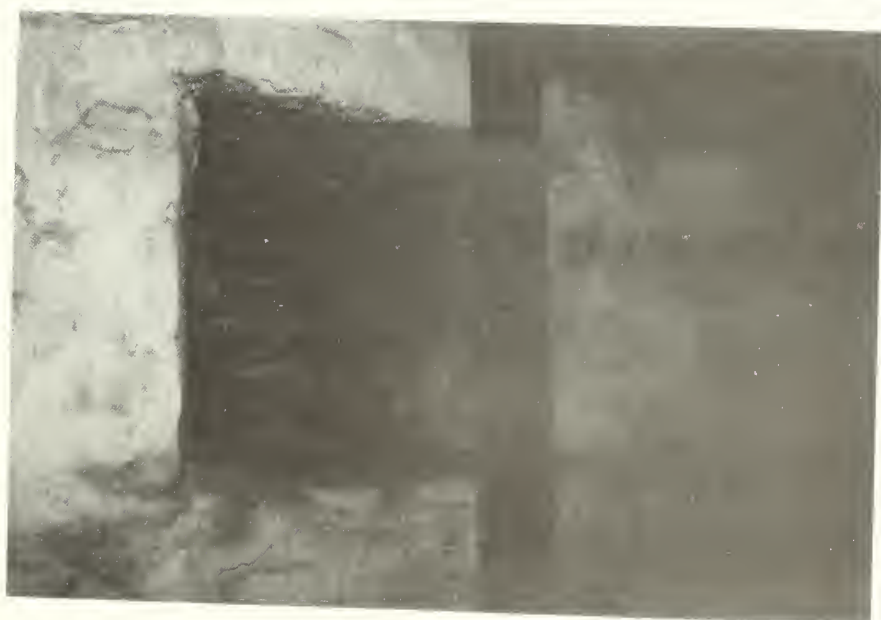
Illustration A75.

Opening in wall between bell tower and main nave, partially closed with brick. 6/84. R.L.C.

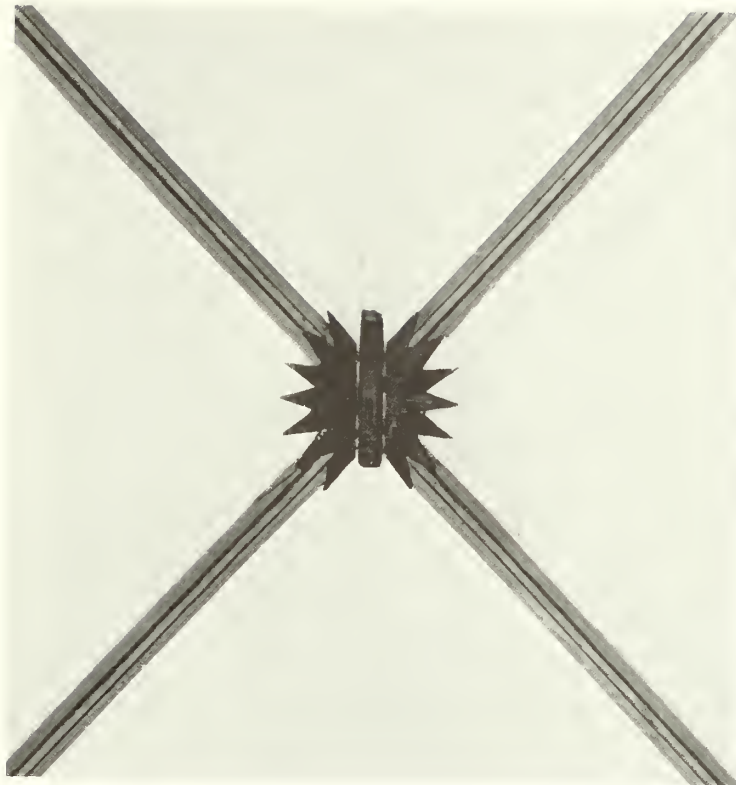
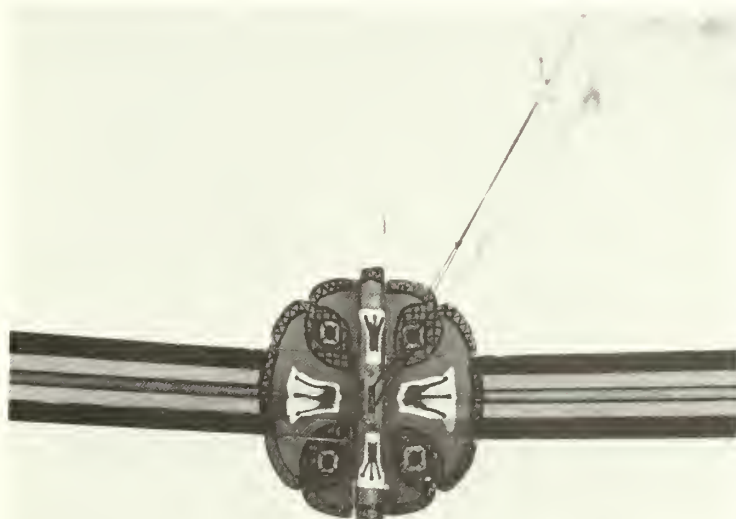
Illustrations A99 and A100.

Ceiling medallions. 8/84. P.C.C.

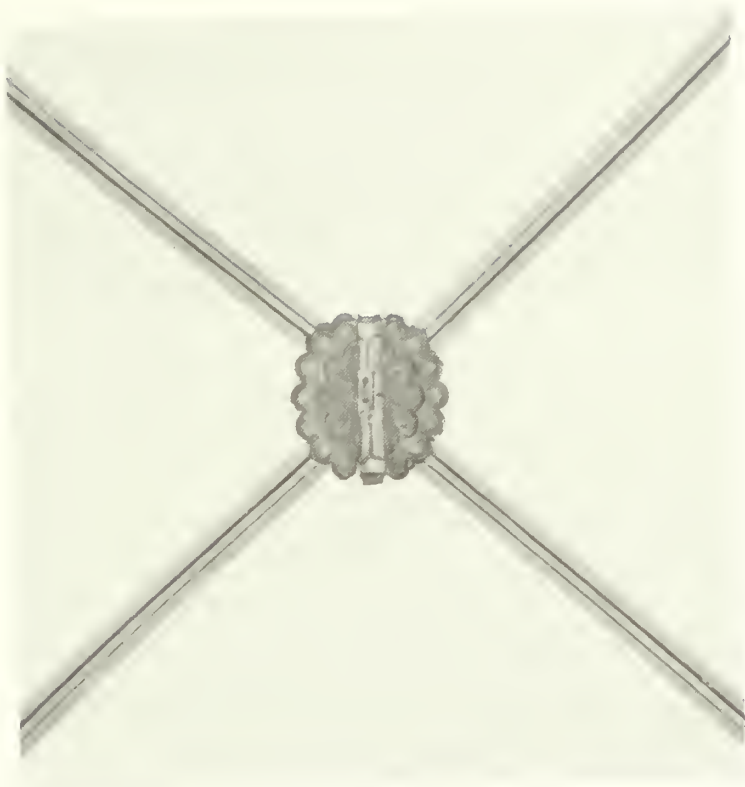
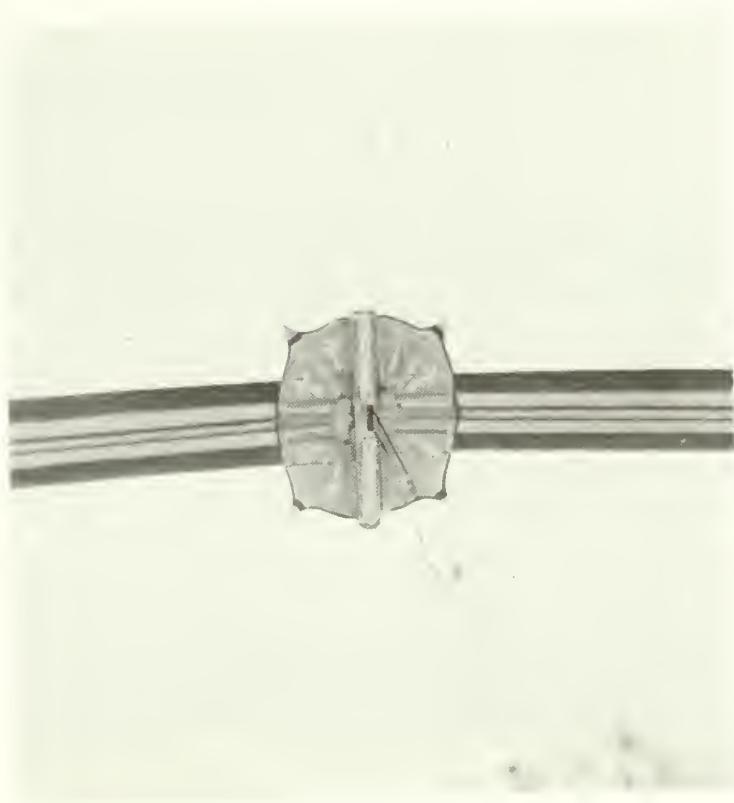
Illustrations A101 and A102.

Ceiling medallions. 8/84. P.C.C.

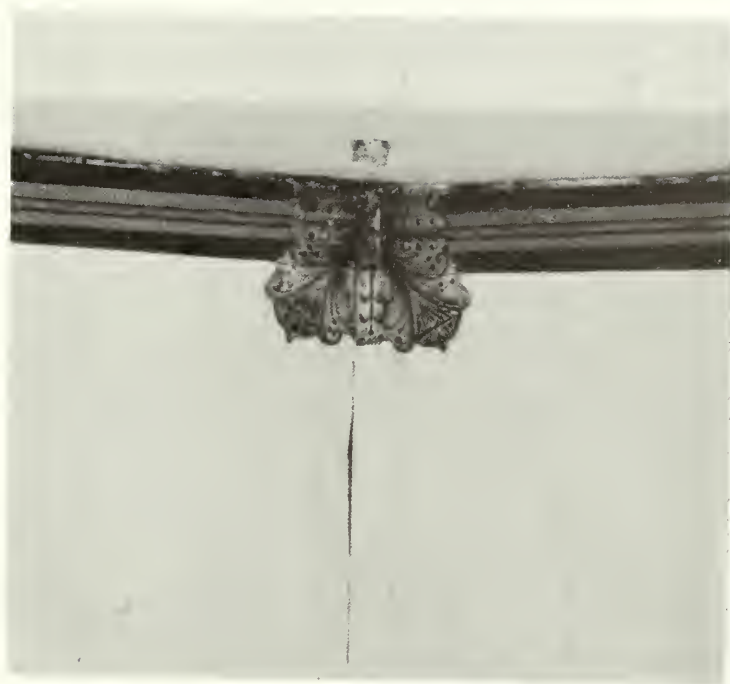
Illustration A103.

Ceiling medallion at 'south' wall, 1888 nave. 8/84. P.C.C.

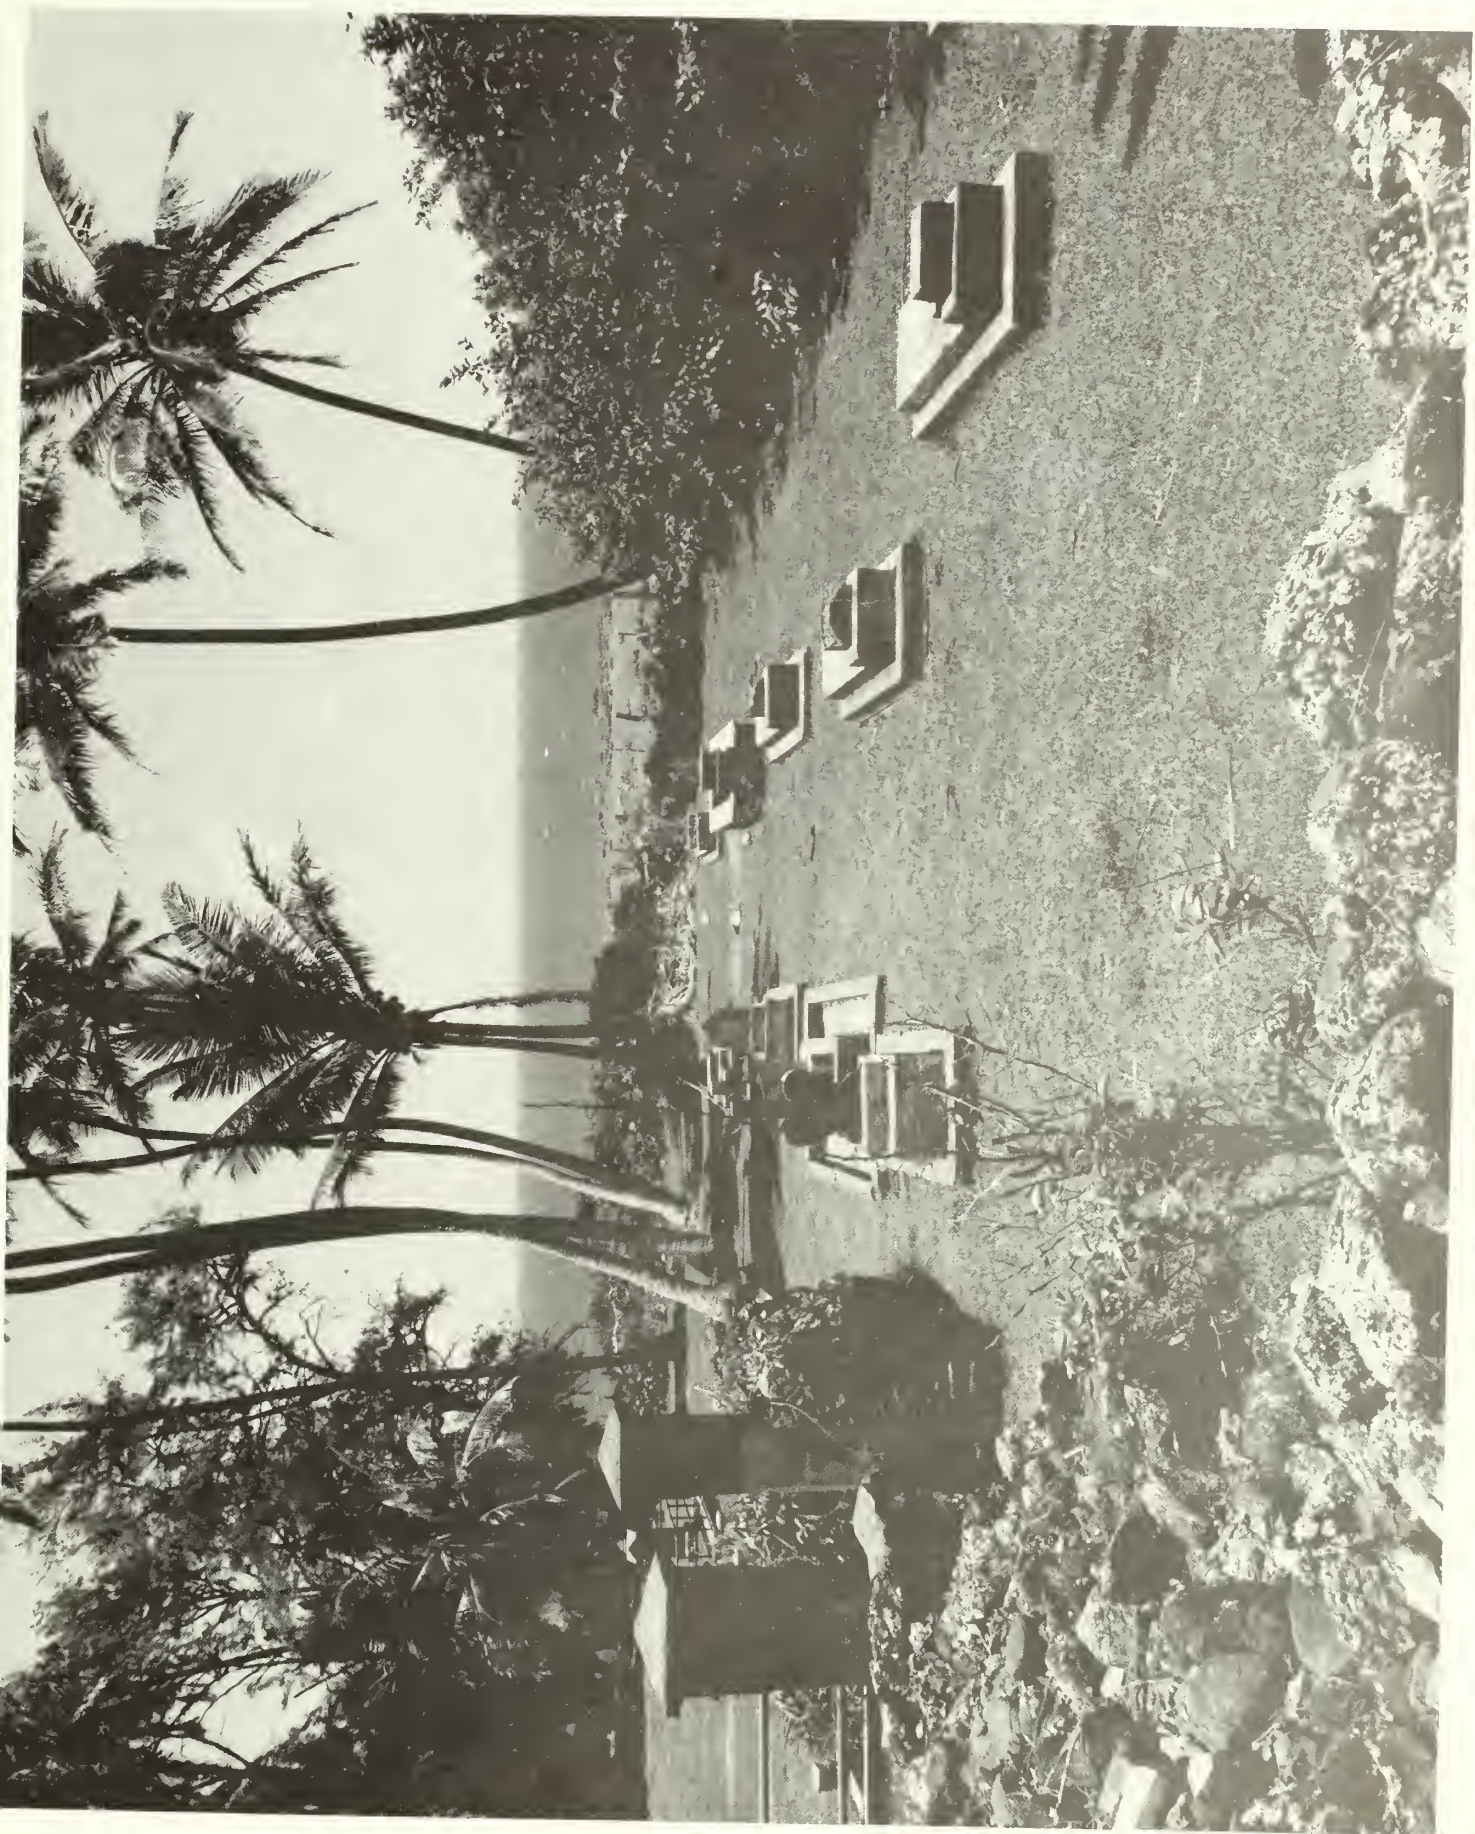
Illustration A104.

View of site at 'east' side of church. 6/84. R.L.C.

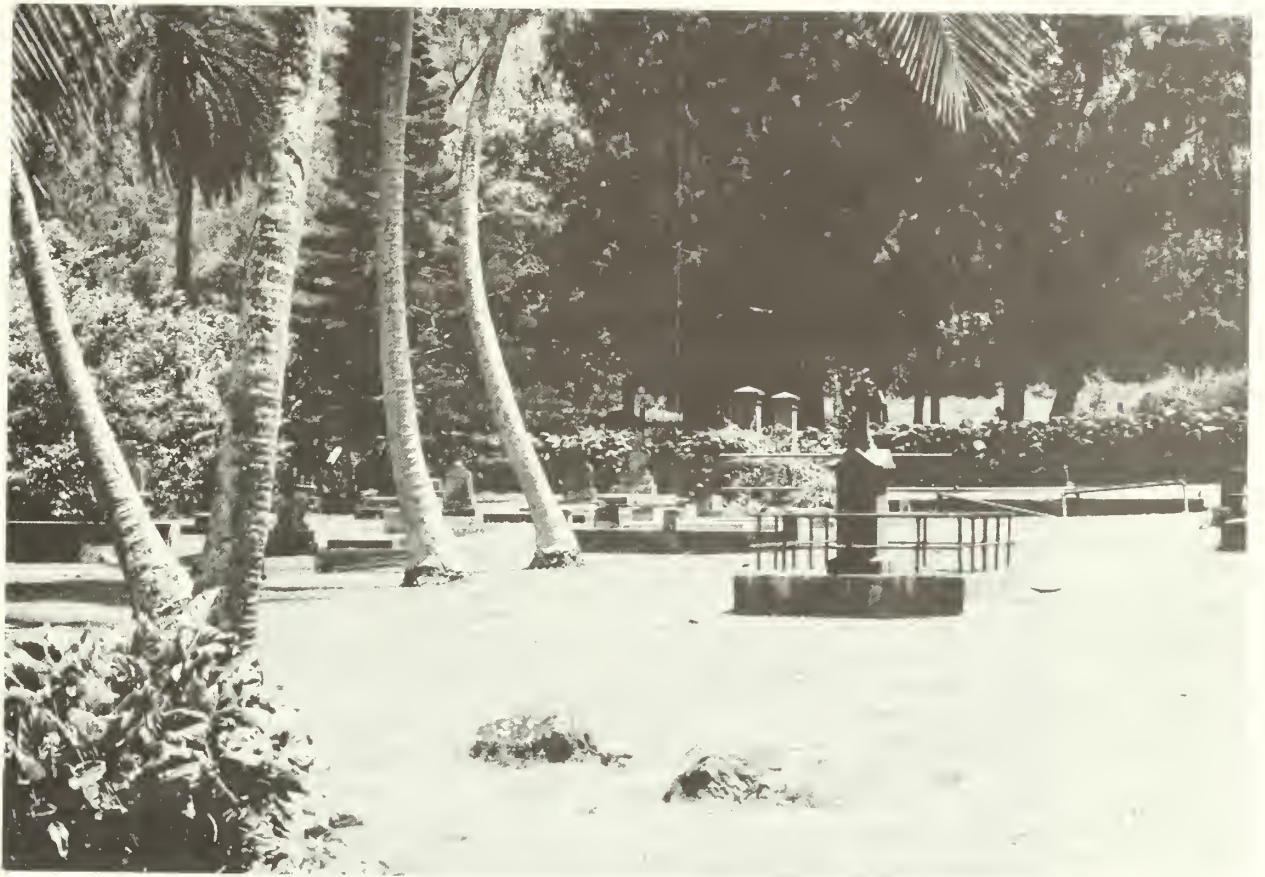
Illustration A105.

View toward south of church site 'east' of church. 6/84. R.L.C.
